A Framework for Understanding the Role of Stream and Wetland Restoration in Cleaning Up the Chesapeake

Presentation to Chesapeake Bay Commission Members

October 27, 2023

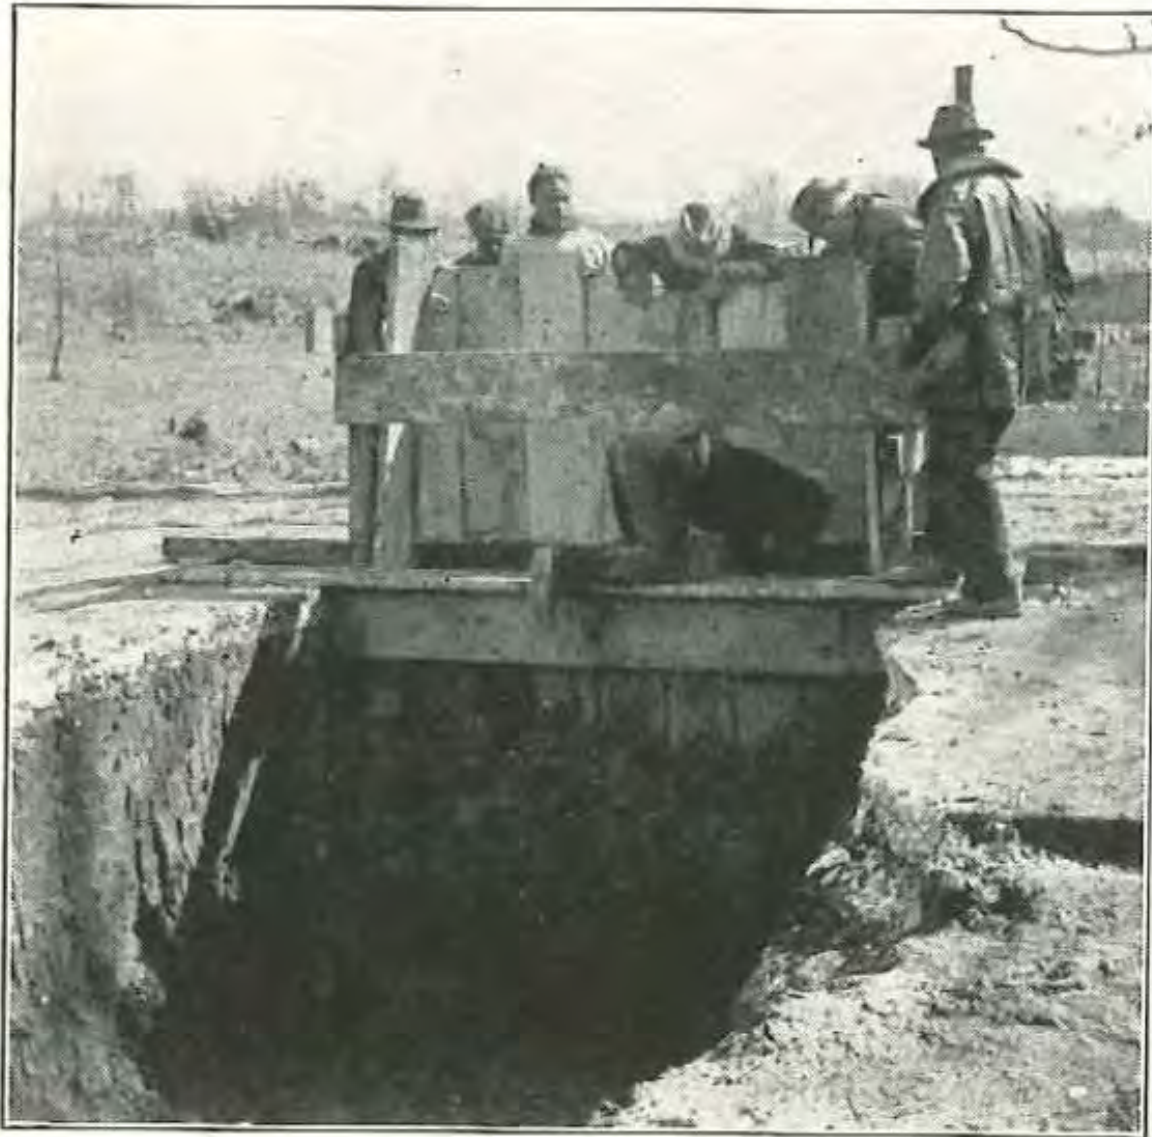
LOWERING OF CULVERT ON SPA ROAD BY
STATE ROADS COMMISSION IN ORDER TO DRAIN
THE UPPER REACHES OF SPA CREEK.

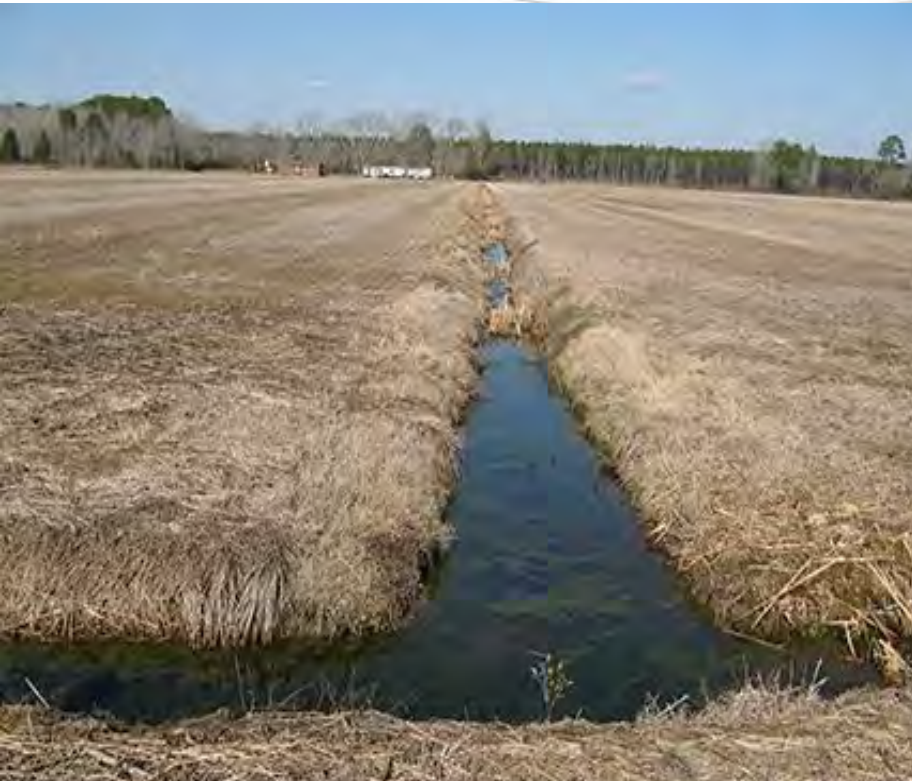
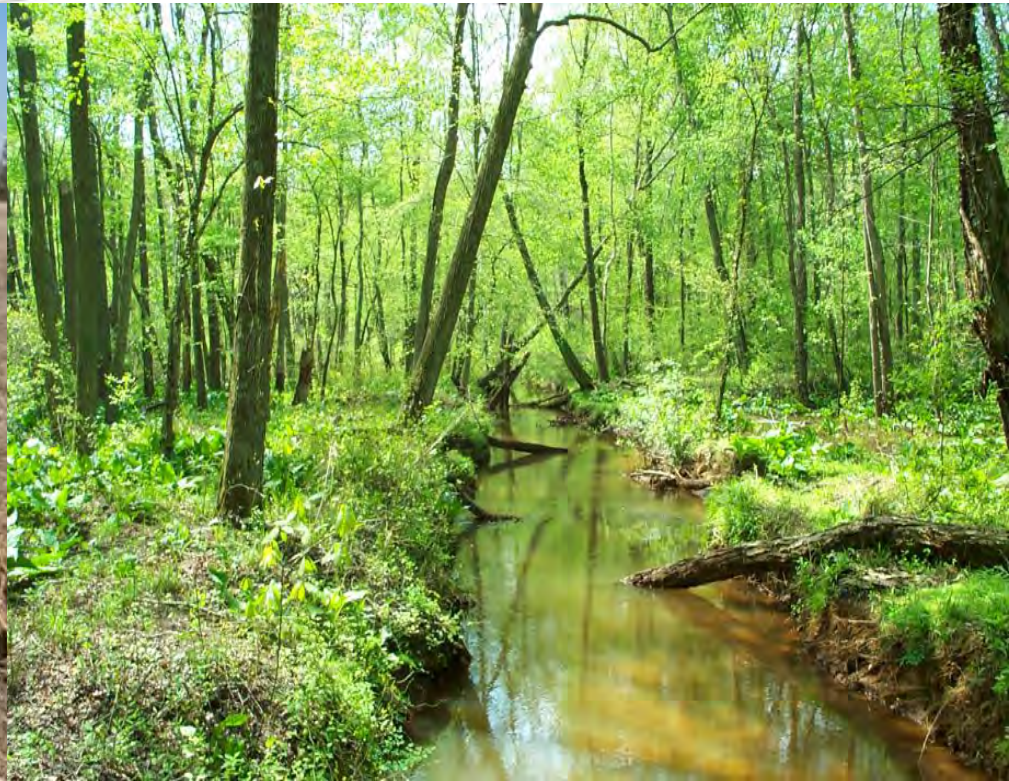
Projects Located In	Acres Drained	Miles of New Ditch
Anne Arundel County ...	499.9	27.9

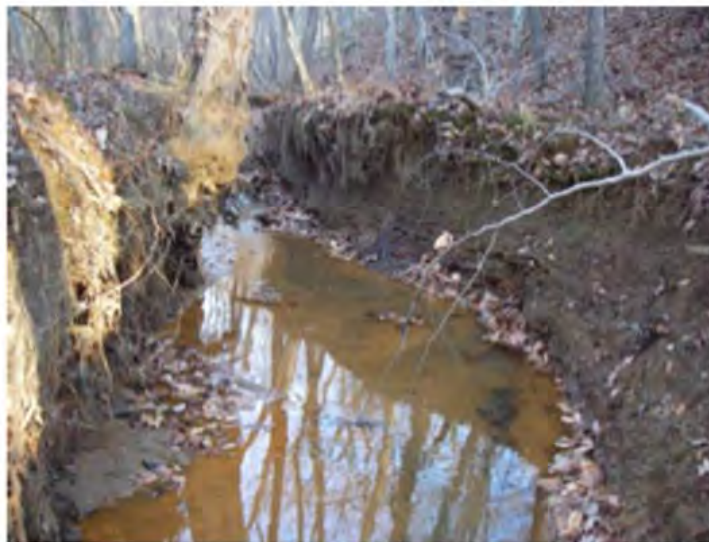
Perennial Stream Sediment Yield

Assessed Perennial Stream Miles = 410

<u>Sediment Yield</u>	<u>Miles</u>
High	134
Moderate	210
Low	66

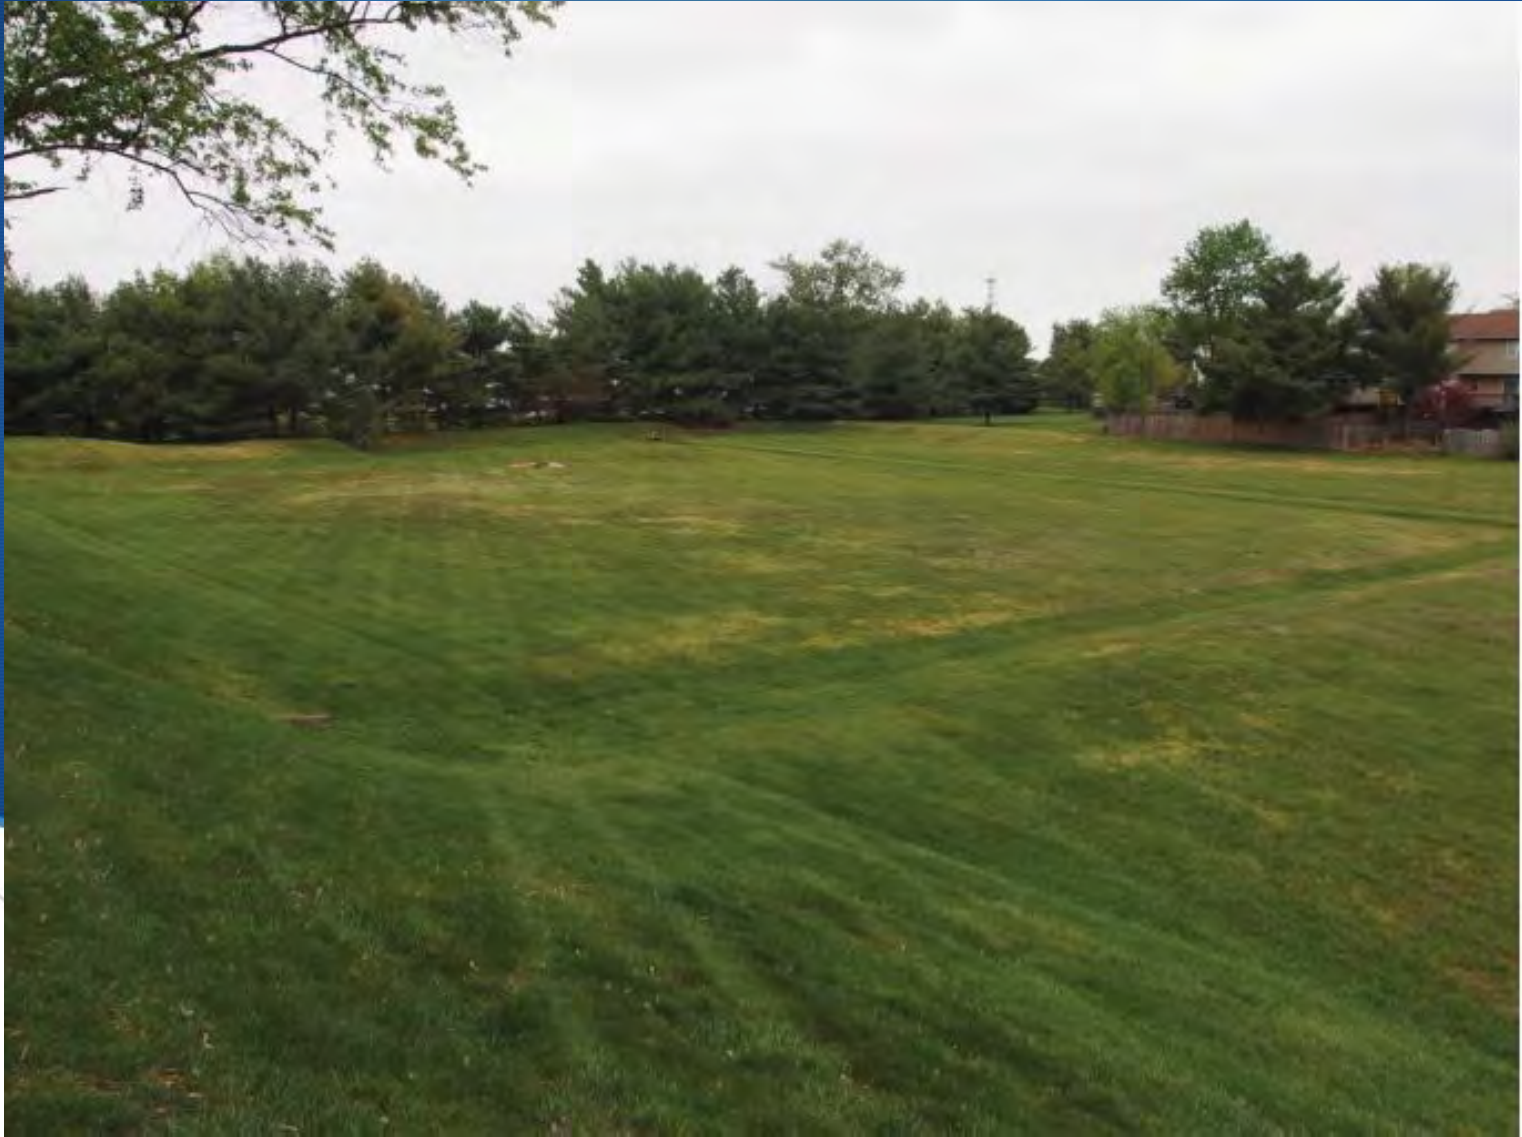
MILLRACE DETENTION POND RETROFIT CONSTRUCTED WETLAND DESIGN SITE PLAN

Millrace Stormwater Wetland Retrofit

VEGETATED BENCH

CONSIDERING INFLOW CHANNEL

RETAINING WALL

WETLAND ISLAND

RECREATION FIELD

FLORISSANT PAVED BIKEWAY
